# Anomaly Resolution in the International Space Station

# ECOMM Anomaly

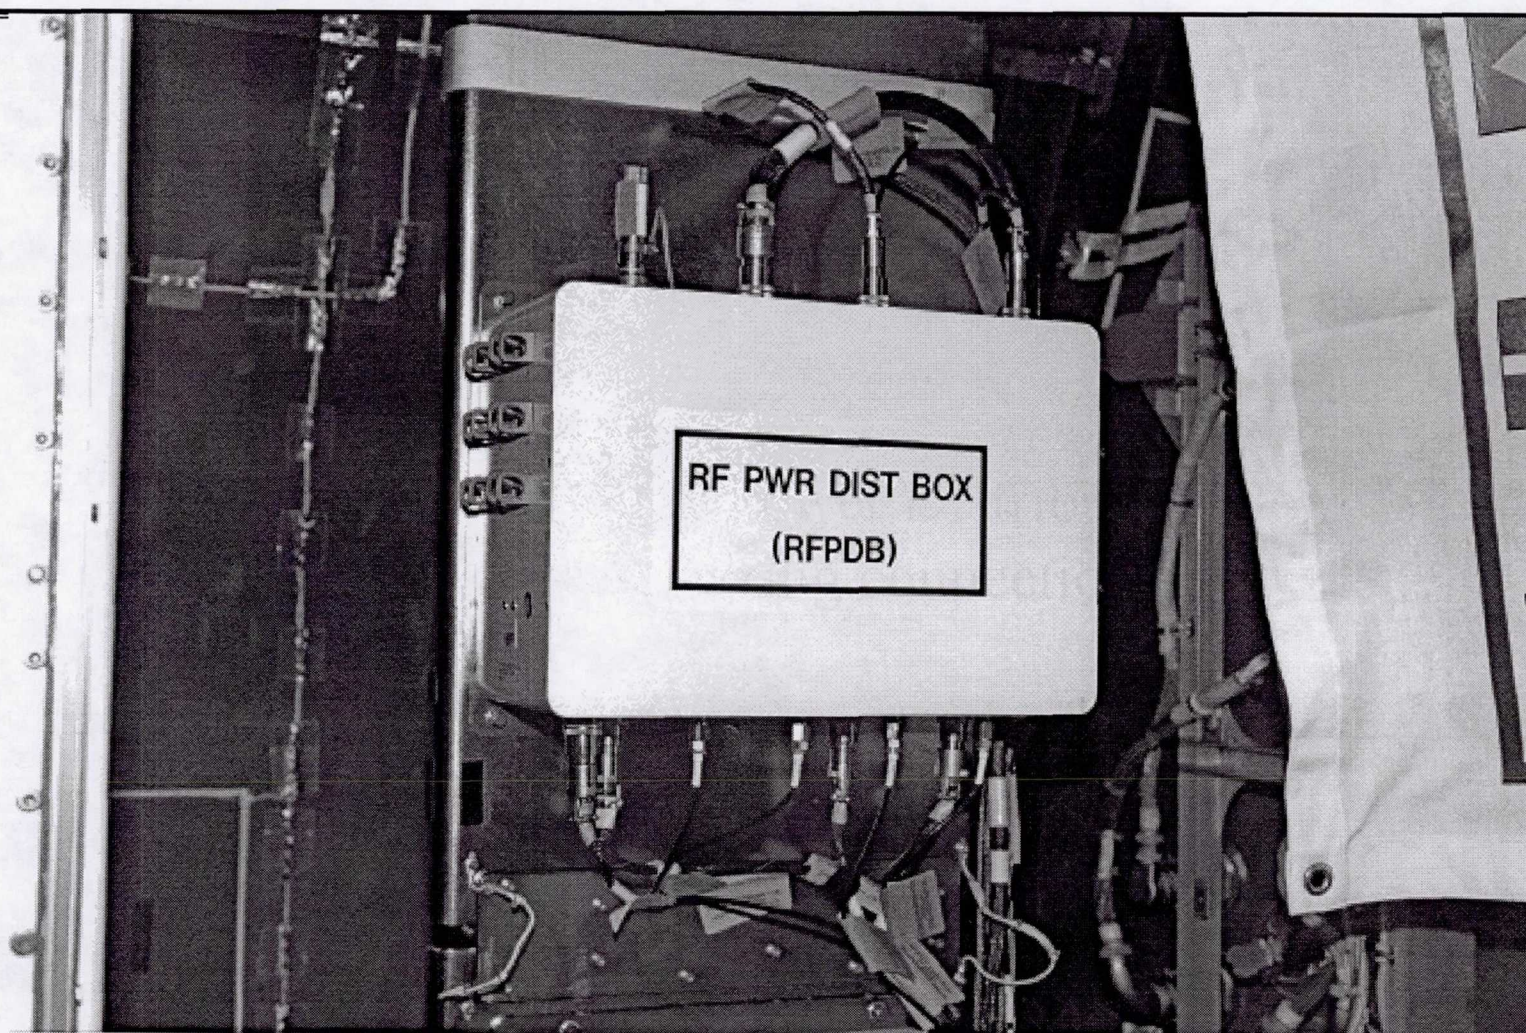
## Radio Frequency Power Distribution Box (RFPDB)-Note wiring connections.

- ◆ The procedures were added to the crew timeline on ST-96/Flight 2A.1
- ◆ The tests were run, using the flowchart for Manual Fault Isolation
- ◆ A manual switch in the RFPDB was identified as being faulty, so the RFPDB was removed and replaced

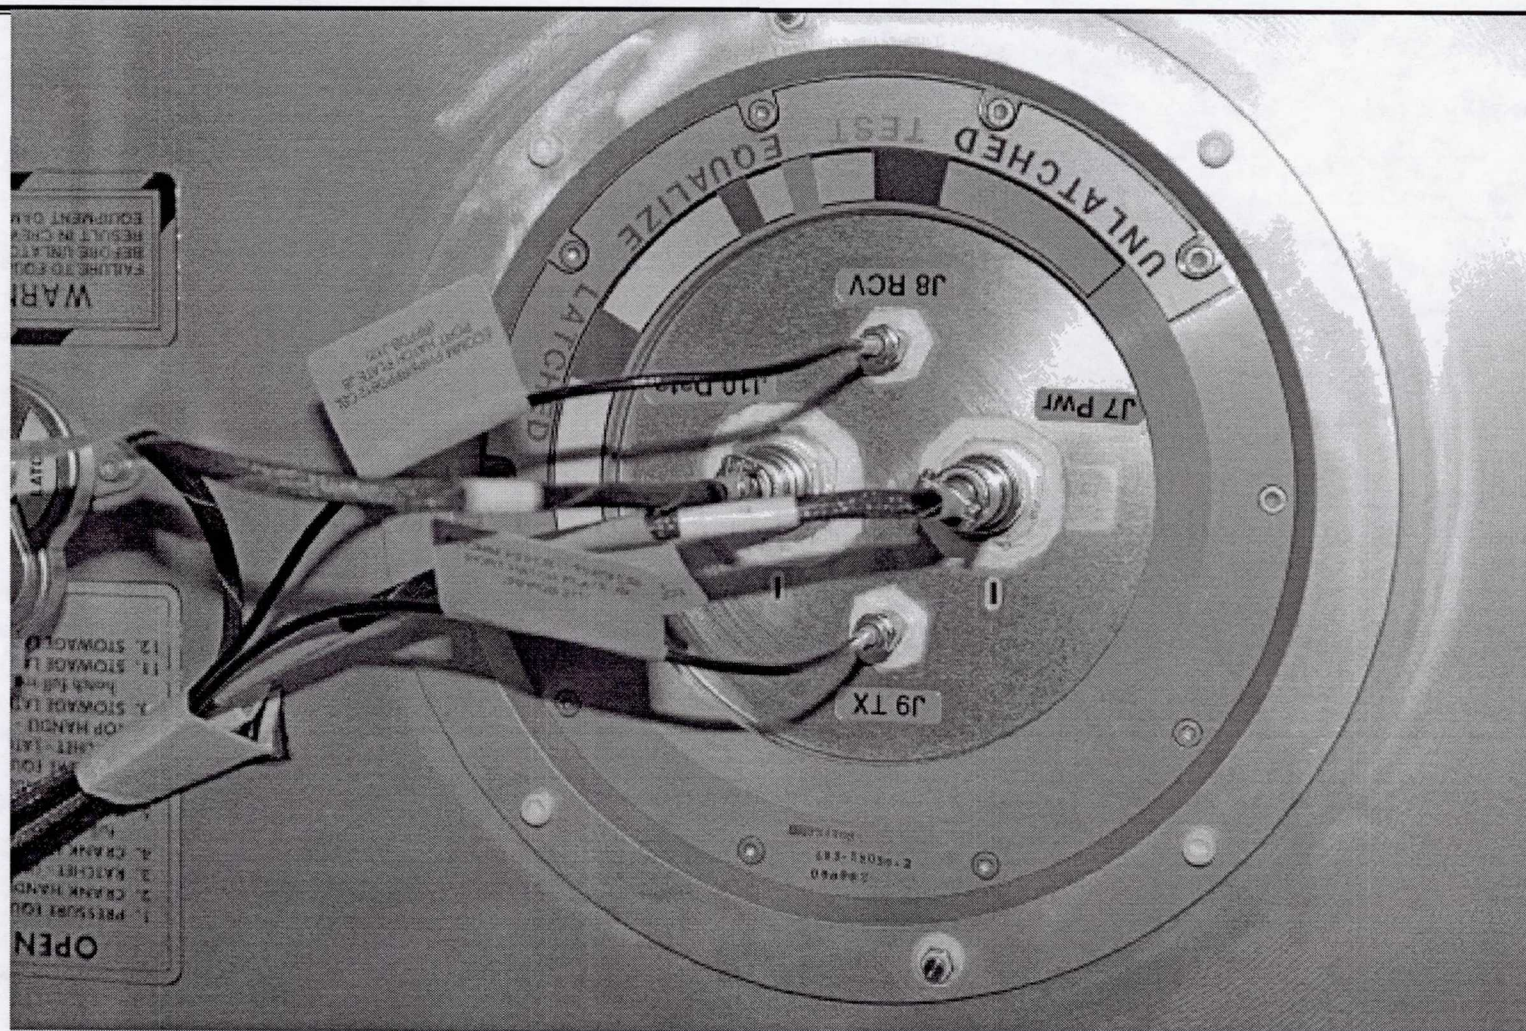
## ECOMM wiring pass-through in hatch.

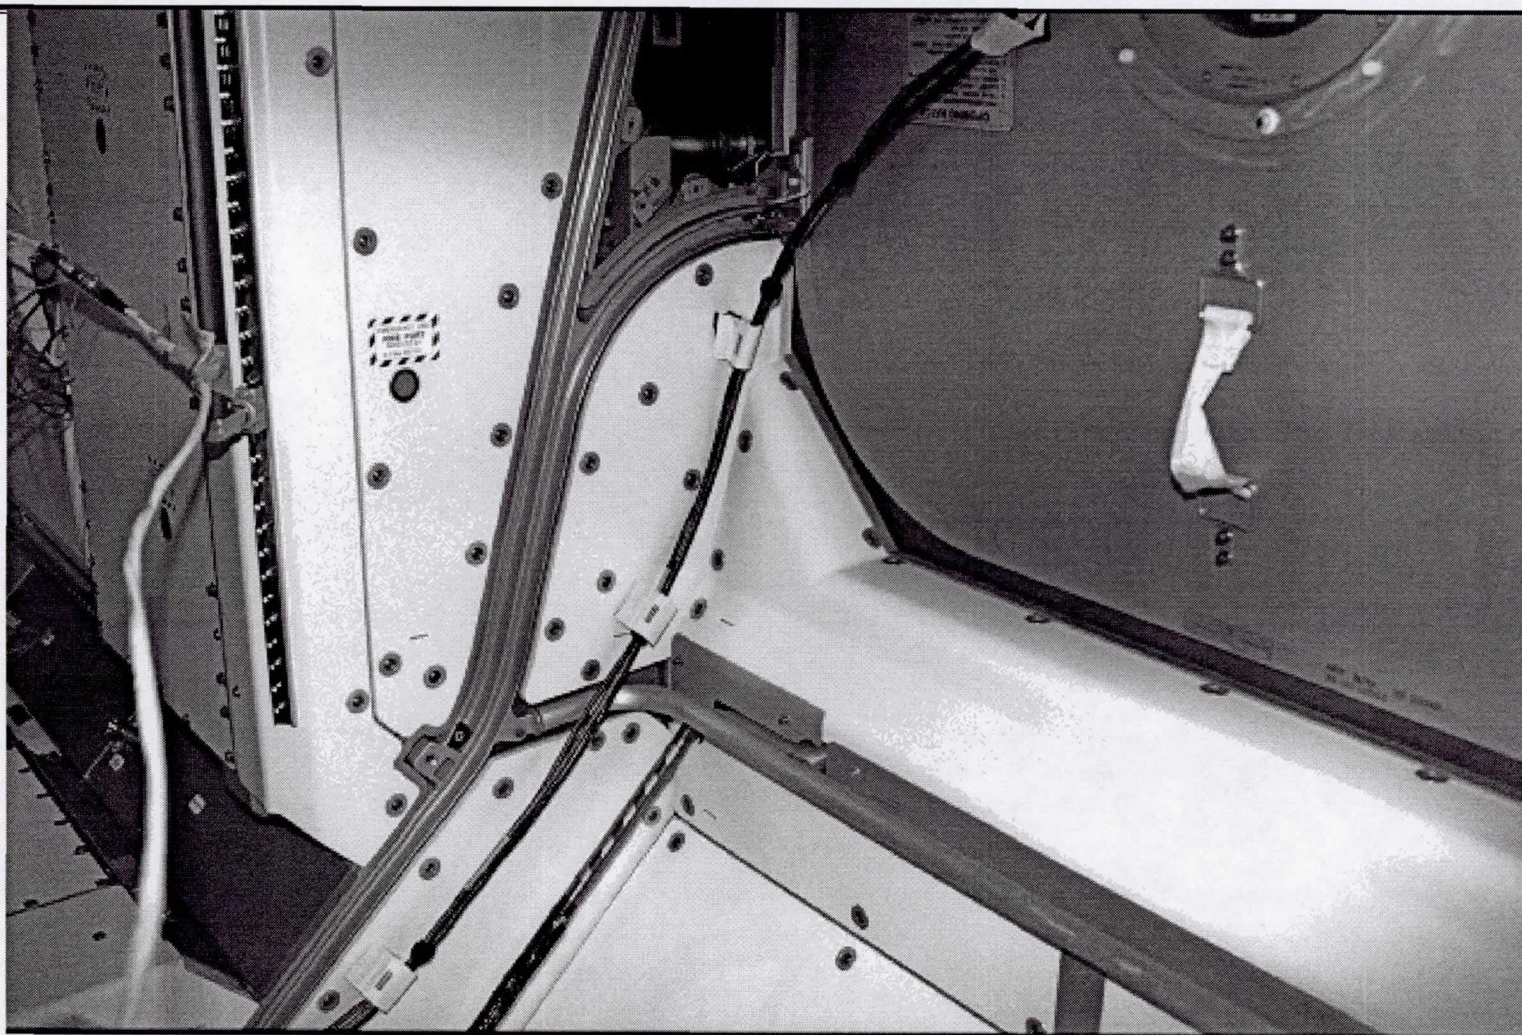
ECOMM wiring run to portside.

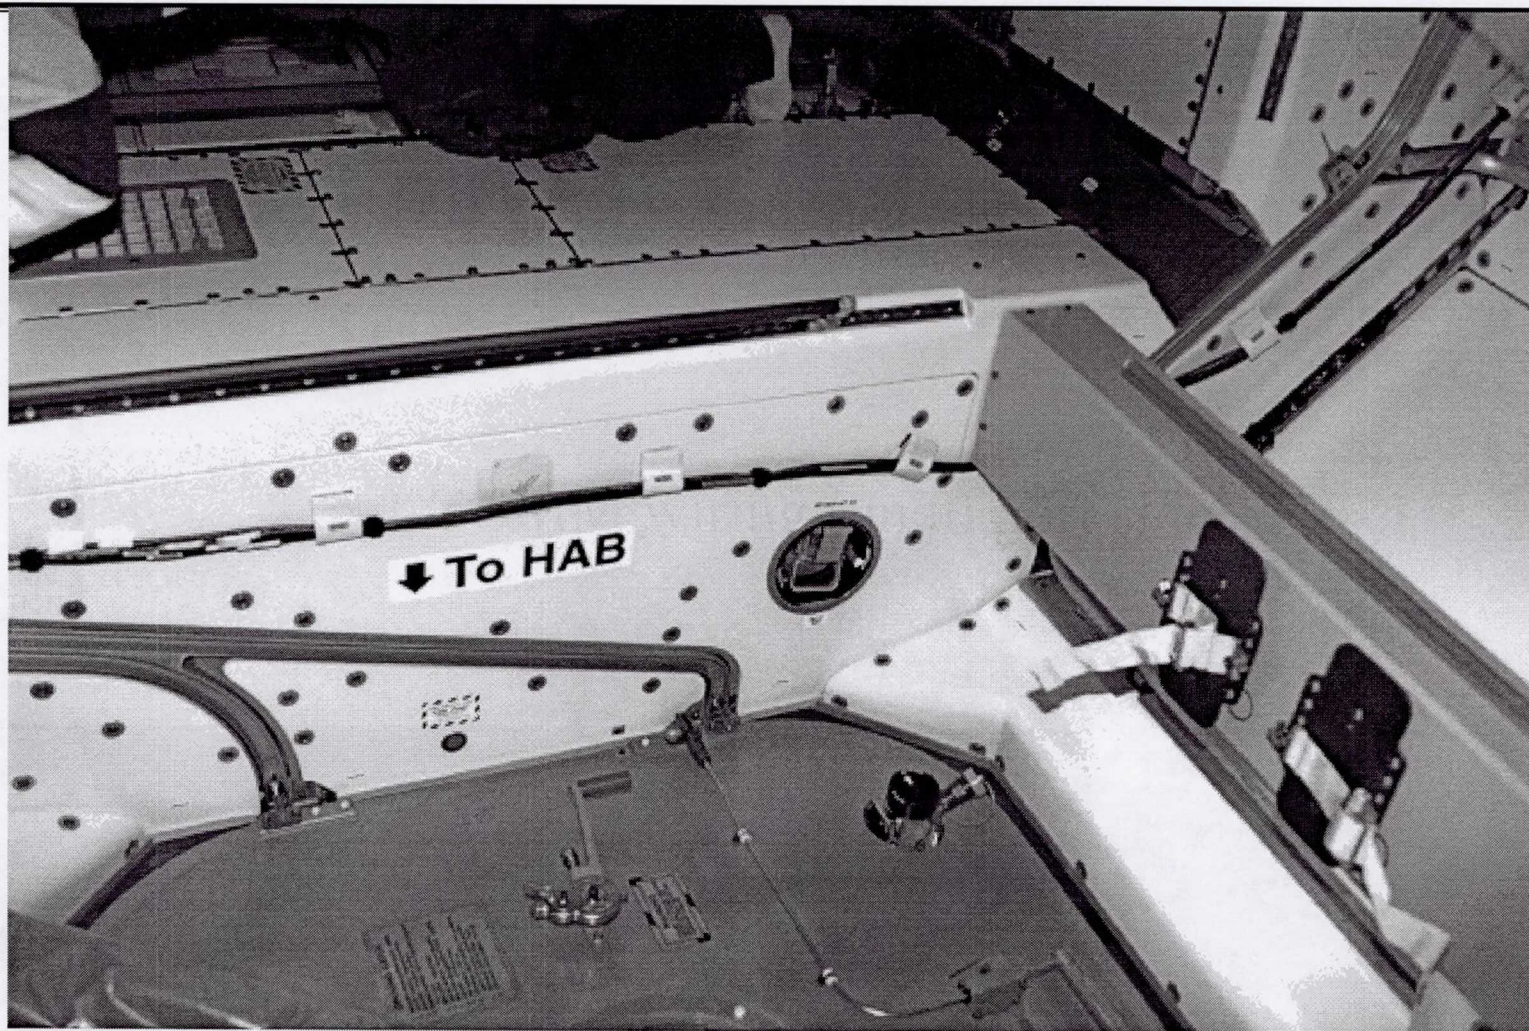
## ECOMM wiring run to port side

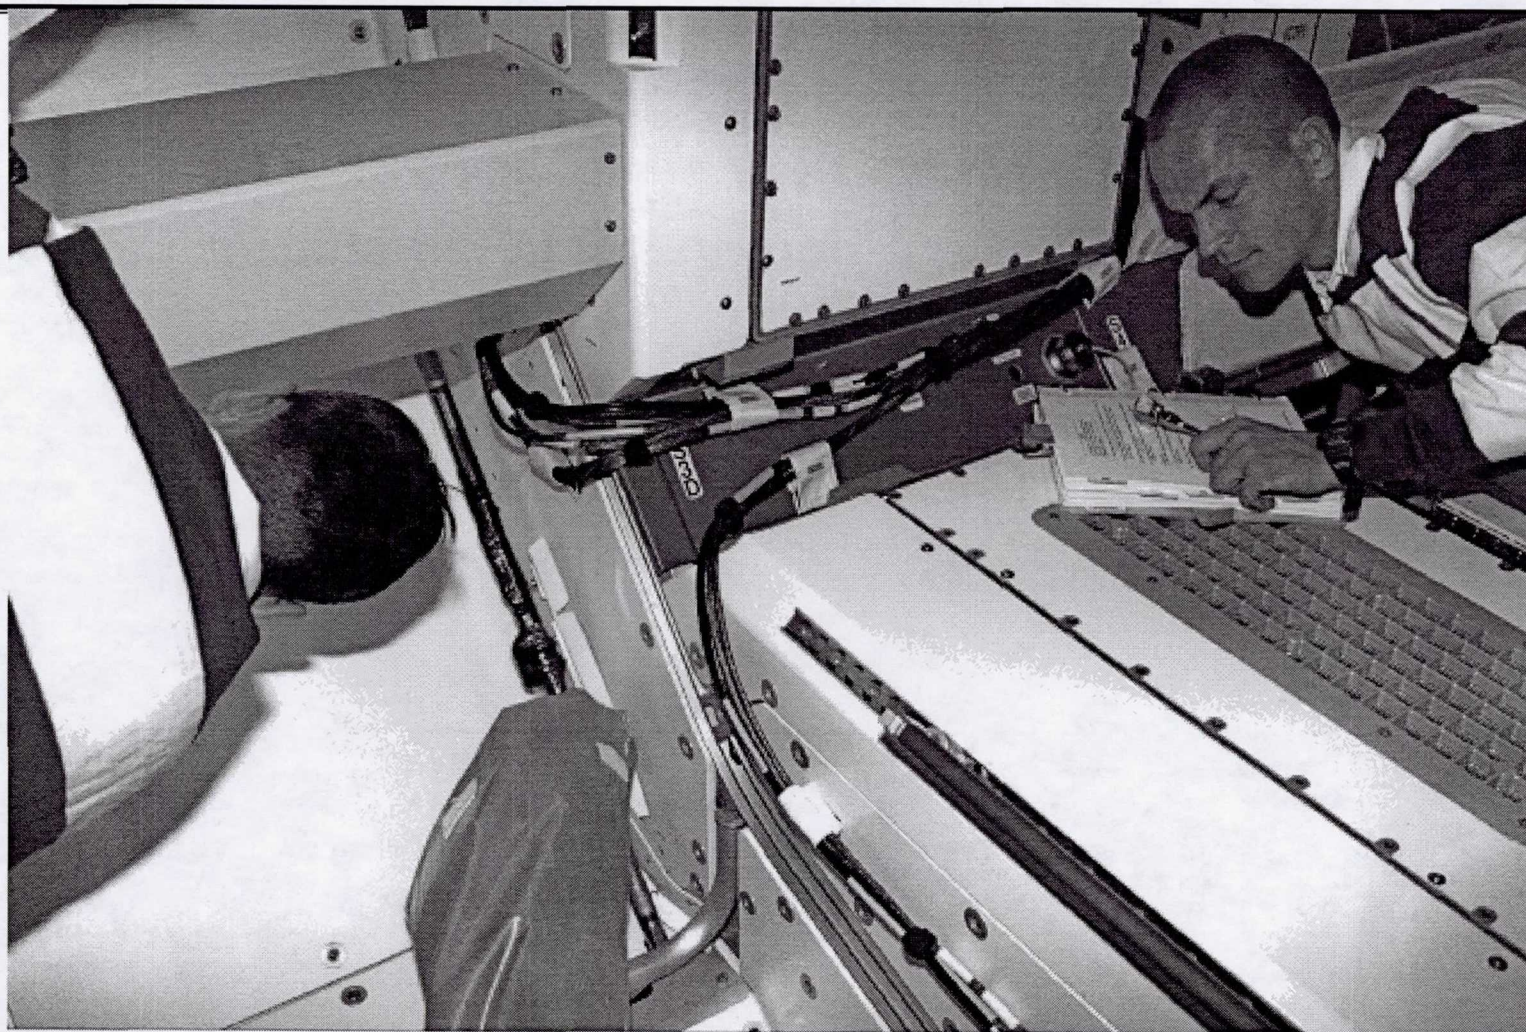
STS-88 Crew inspects ECOMM wiring on installation of the system.

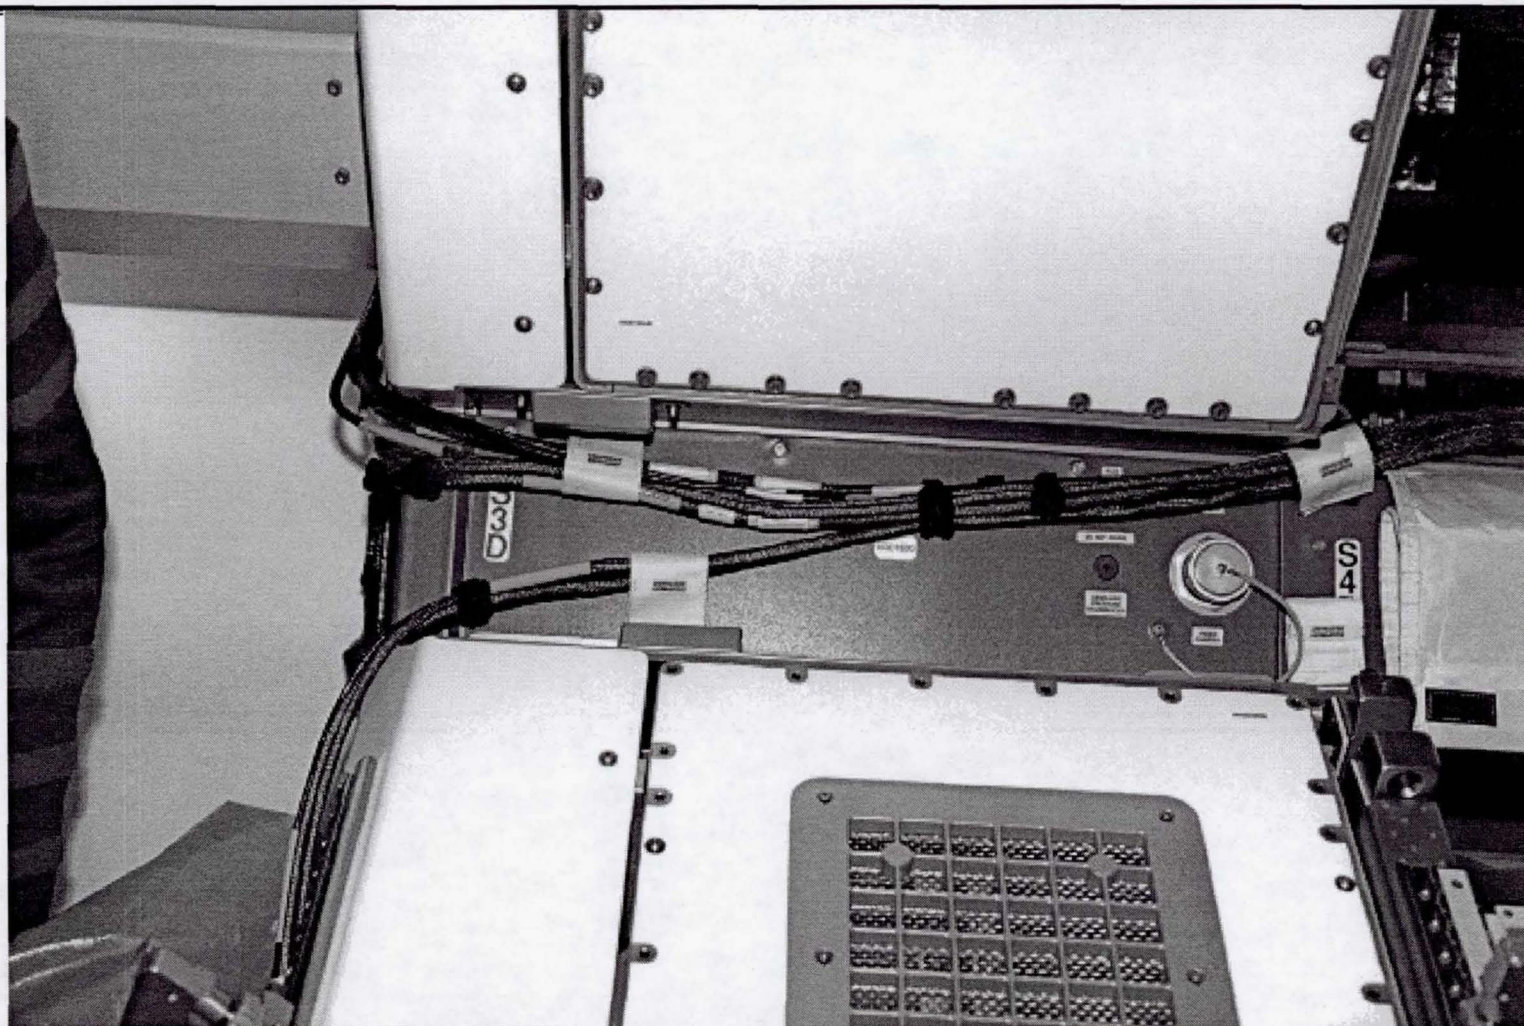
# ECOMM port/starboard antenna wiring split
